Barn at 332 West Street, Amherst MA

Conditions Assessment and Scope of Work Report

January 2014

Gusakov Woodworks
www.gusakovwoodworks.com
willgusakov@gmavt.net
802-318-8664

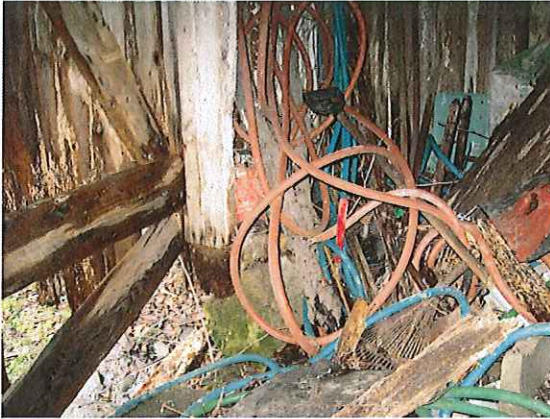
Figure 1. Condition at North East corner (5C). Note concrete foundation pier rolling outwards.

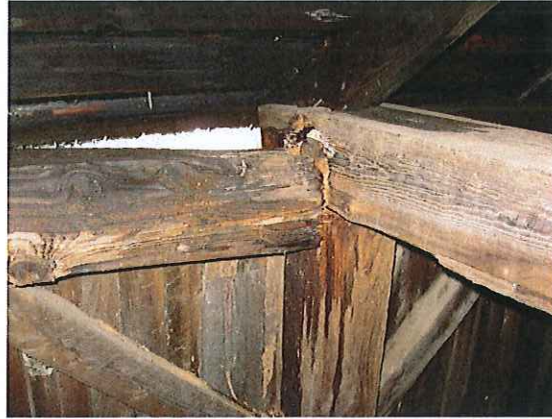
Figure 2. Connection at top of post 4C, showing rotted ends of tie beam 4, plate 3C-4C, and resulting drop of post and plate.

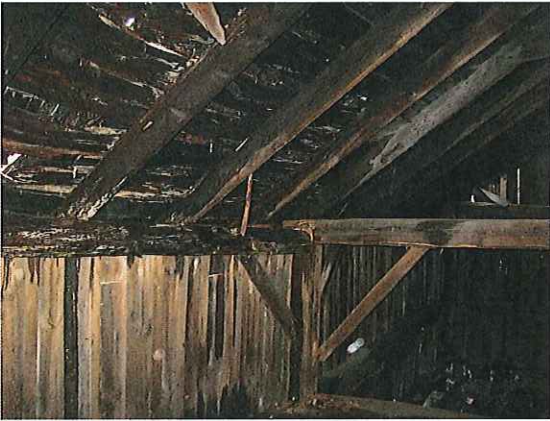
The original roof covering consisted of wooden shake-shingles over pine slab skip-sheathing. These are still present, covered on the north pitch by at least one layer of asphalt roll roofing, and on the south side by some type of corrugated asphalt product. The south pitch is generally in better shape, but evidence of leaks are present, especially around the transition from main roof to the shallower pitch of the milking shed. The north pitch of the roof is in very poor condition, with many leaks and several gaping holes (Figures 3, 14).

Figure 3. View of plate 3C-4C, showing roof leak and resulting rot of sheathing, rafters, and plate.

- Strengthen any damaged rafters with 2x6 sisters
- Strip existing asphalt roof covering
- Strip wooden shingles, and repair rotted board sheathing as needed. If the majority of sheathing seems suspect, a layer of ½" plywood sheathing may be added over the board sheathing
- Apply standing-seam steel roof.

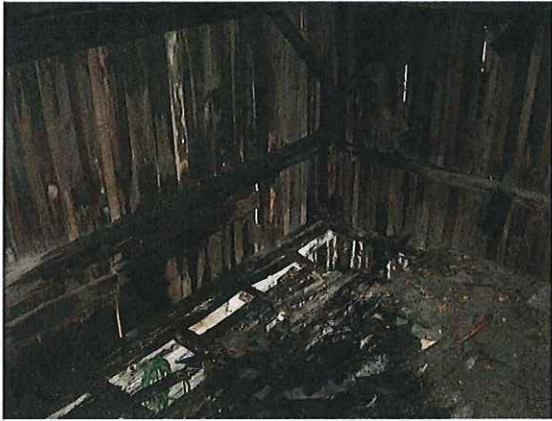
With the dairy retrofit, two loft floor systems were added to the main barn, to store hay. These are simply framed, with 4x4 joists laid over carrying beams. Both are in poor condition, with substantial rot and failure thanks to roof leaks (Figure 4). There is also a wood-framed floor added at ground level to the north aisle of the barn; this is in as poor condition as the loft floors, for the same reasons.

Figure 4. Loft floor in North East corner (5C), showing effects of major roof leak on loft floor and framing.

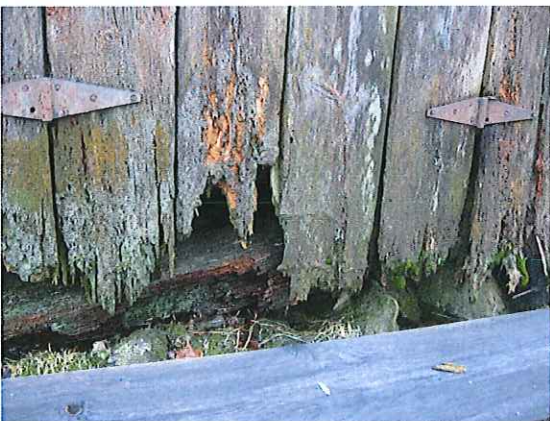
- Sill beams, although made of chestnut which is renowned for its resistance to rot, are largely damaged and in need of repair or replacement. This is due to a variety of causes, including foundation failure, water infiltration due to roof leaks and rotted/missing sheathing, and concrete floors and foundation that partially or fully encase the beams (Figures 5,9).

Figure 5. Condition of sheathing and sill along wall C. Note remains of original fieldstone foundation, amongst rotted remains of sill.

- Jack posts, remove failed piers, dig holes and pour new concrete footers and piers
- Install new sill beams onto new piers
- Where needed, repair or re-cut post feet, then lower posts into new sills and piers

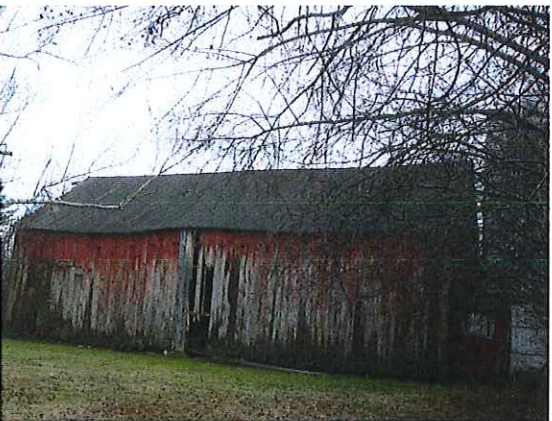
- The north wall of the barn between bents 2 and 5 shows the most damage, from a combination of roof failure and foundation failure (Figure 6). The three wall plates in this section appear rotten and in need of repair or replacement, thanks to large leaks. The same leaks have caused the joint between post 4C and its tie beam and two plates to rot completely, and that rot in combination with foundation/sill failure has allowed post 4C to drop nearly 12", deforming the wall (Figures 2,3). Wall girts, tie beam ends, and post 5C may also need repair or replacement thanks to this water infiltration (Figure 4). Post 3C has been repaired in the last few decades, with the bottom 3' replaced with a pressure-treated 6x6, sistered on with a 2x6 fish plate (Figure 13).

Figure 6. View of North wall (wall C). Roof leaks and foundation failures have combined to deform the frame, immediately apparent from the exterior, especially near post 4C.

- Replace spreader beams 3-5
- Repair or replace posts 4C and 5C
- Replace wall plates 3C-4C and 4C-5C
- Replace upper wall girts in north wall
- Repair north end of tie beam 4

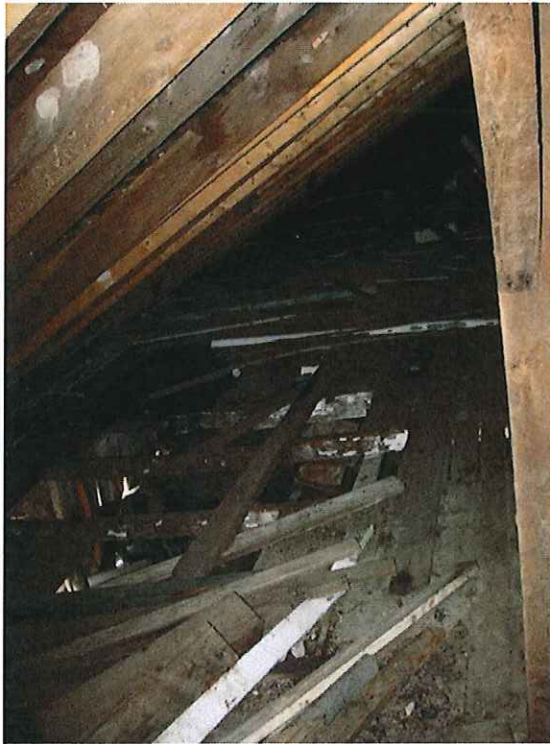
The milking shed is in fair to poor condition. While the wall framing is largely intact, at least half of the ceiling joists are rotted and failing, and a large number of the rafters are compromised (Figures 7,11). At some point in the last 30 years, repairs were made to rotten rafters with modern 2x6 sisters. The slab floor and the concrete stem-wall foundation are beginning to fail, and will continue to deteriorate.

Figure 7. View into upper level of milking shed. Note rotters on majority of rafters, and rotted joists and loft flooring.

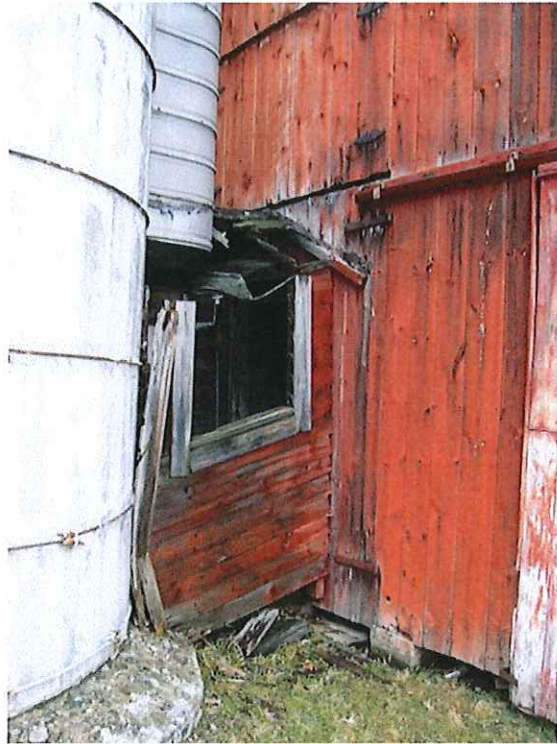
Though silo structural analysis is outside the author's expertise, the silo and its foundation appear to be in sound condition. However the silo is located in front of the north aisle entrance, between the barn and the road, and the silo and the small connector leading from it to the barn block usage of the original hung doors into that aisle. The connector is thoroughly deteriorated, and causing problems at its intersection with the barn (Figure 8).

Figure 8. Silo, barn and connector. Connector has completely failed, and is leading to deterioration of barn sheathing and framing.

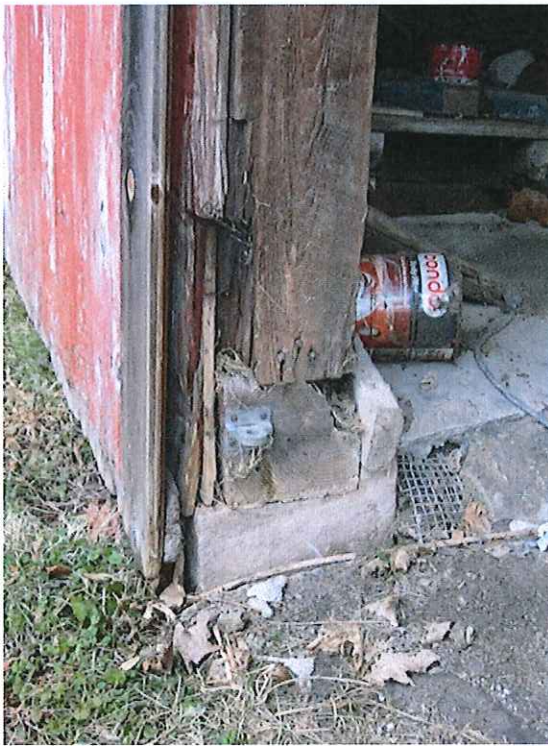
Figure 9. Concrete pier under door post near post 1B. Note sill encased in concrete, and resulting damage.

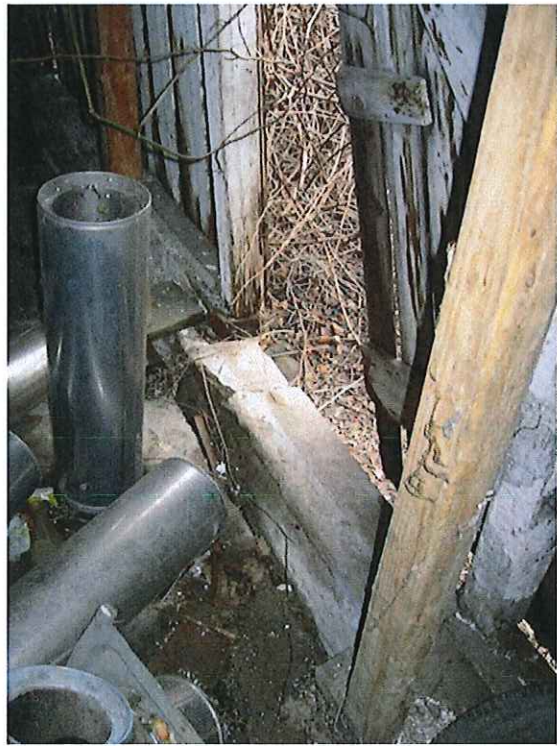
The original timber-framed barn was founded on field-stone piers, likely dry-stacked on grade, supporting the continuous 7x7 chestnut sill beams. At a later date, probably concurrently with the milking shed addition, formed concrete piers replaced the fieldstone piers. These concrete piers were poorly executed, not footed below frost and with the concrete partially encasing the sills, and most have failed or are beginning to fail (Figures 1,9). Additionally a concrete slab floor was poured in the south aisle of the main barn, partially encasing the sills; this slab is substantially cracked and heaved. The milking shed foundation and slab floor are failing due to frost heaving and (likely) improper footing (Figure 10).

Figure 10. Foundation stem wall and slab along south wall of milking shed. Note outward lean of stem wall and visible cracking.

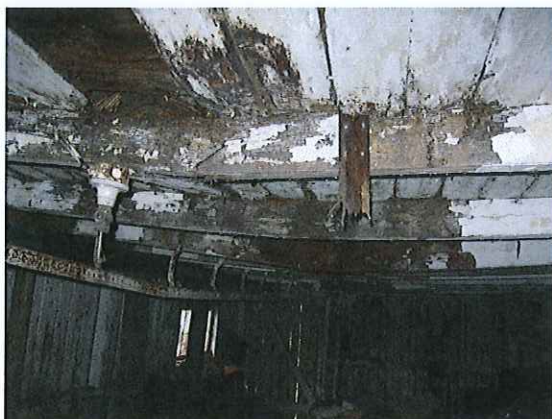
Figure 11. View of milking shed lower level, showing rotted and falling joists.

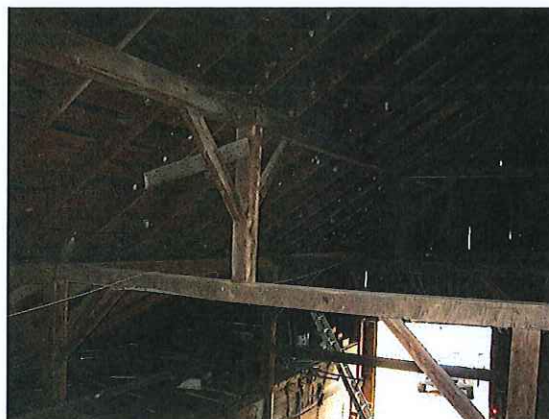
- The spreader beams in bents 3-5 were removed from the frame to make way for the hay-track as part of the retrofit from tobacco barn to dairy barn, with no steps taken to account for the resulting loss of roof stiffness (Figure 12).

Figure 12. Purlin system, at bent 3, showing missing spreader beam. Intact spreader beam can be seen at bent 2 in background.

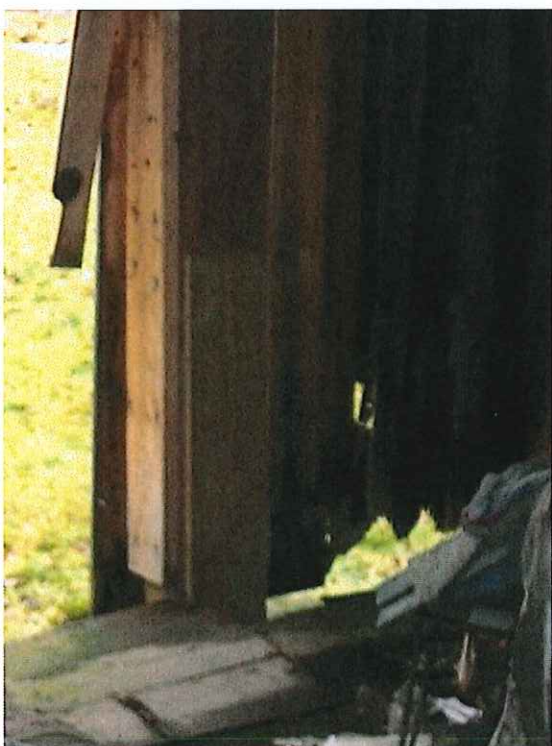
Figure 13. View of inadequate repair at bottom of post 3C.

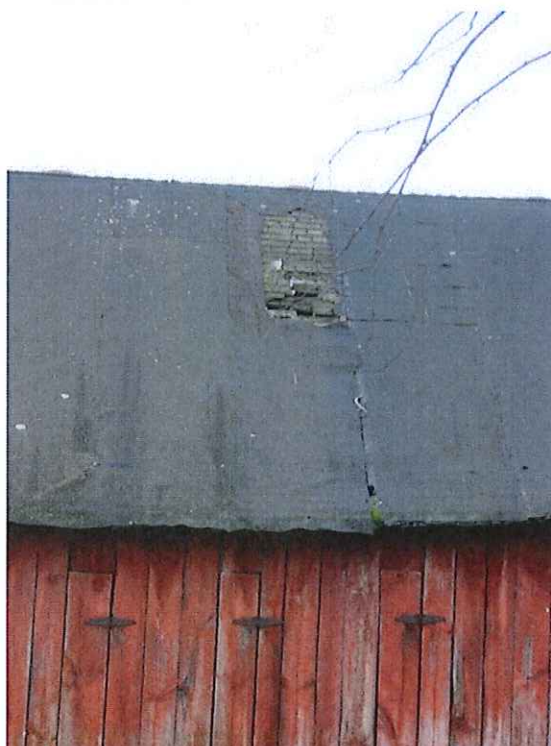
Figure 14. Hole in north pitch of roof, showing asphalt roll roofing and underlying wood shingles.

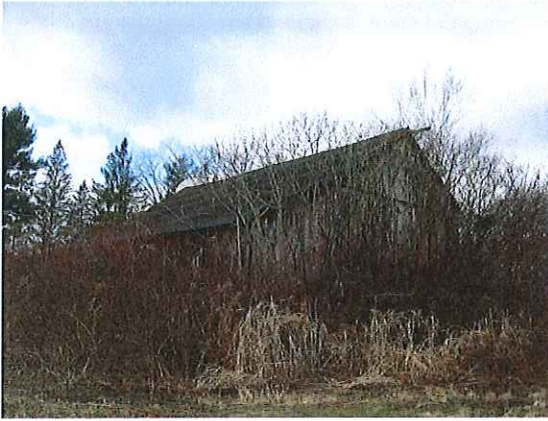
The barn is well sited, located at the crest of a gentle hill, and does not have problems related to grade or drainage. However the ground immediately around the barn is overgrown with sumac, brambles and other vegetation, which will hold moisture against the building, and whose roots will eventually damage the foundation (Figure 15).

Figure 15. Overgrowth at perimeter of barn.

- Clear away the dense vegetation from around the barn, at least a 10' swath
